ETL 1110-2-360

31 December 1993

Engineering and Design
BRAKE WHEEL PROBLEM ON TAINTER GATE HOIST MACHINERY

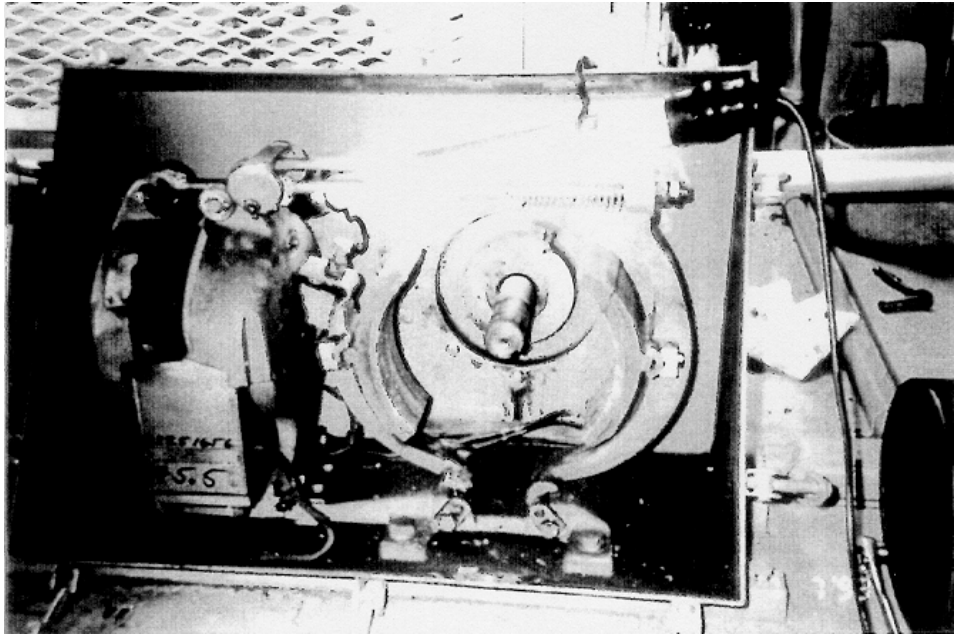
a. On 6 July 1993 the No. 2 tainter gate at Old River Auxiliary Structure fell a distance of 2 m (6-1/2 ft) from its opened position and impacted the gate sill. The damages included the service bridge’s downstream concrete parapet wall and handrail, a line shaft segment and its support brackets between piers, and a cooling fan attached to the motor. A team from New Orleans District made a field investigation. The team concluded that the brake failed on the motor controlling the operation of gate #2. The brake failed when the brake drum “walked off” from its shaft (Figure 1). An inspection of other gate motor brake drums at the same facility revealed that another

b. The brake is a Cutler-Hammer Type GH505, 254-mm (10-in.) D-C Magnetic Shoe brake manufactured by EATON Corporation. The brake drum to the shaft has a loose fit which is not adequate for this type of application. A key held by a set screw is used to transmit the torque.

Figure 1. Brake assembly where the brake drum "walked off" from the shaft

a. All facilities having this type of arrangement should be checked immediately. If the above condition exists, the drums should be repositioned and a positive mechanical stop placed on the end of the reducer shaft to secure the brake drums from “walking off.” For example, the shaft can be threaded at the end and fitted with a A325 high-strength bolt with thread locking compound (Locktide) and a large plate washer to hold the drum in place (Figure 3). Locking compound can be used between the brake drum and the shaft.

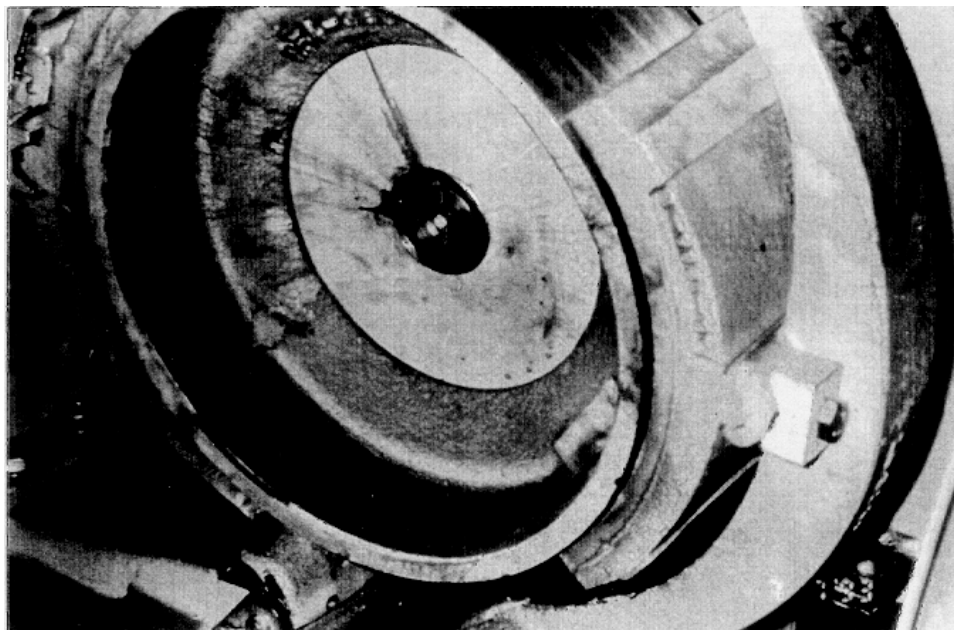
drum had also begun to “walk off” from its shaft (Figure 2).

Figure 2. Brake drum that has "walked off" slightly from its shaft

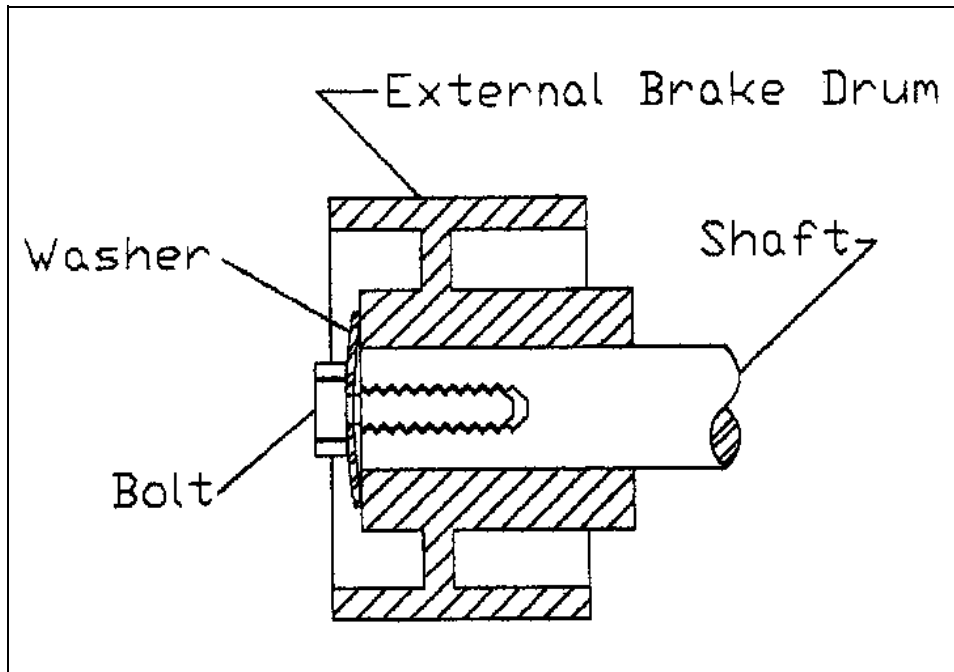
Figure 3. Shaft fitted with a high-strength bolt (no scale)

c. CWGS-14615, Electrical Equipment for Gate Hoists, will be revised by CECW-EE to include a positive mechanical stop to hold the brake drum to the shaft. The brake drum to shaft will have a taper fit or a ASA class FN1, light-drive fit.
